NASA TM-82490

June 1982

*George C. Marshall Space Flight Center
Marshall Space Flight Center, Alabama*

STS-3 MAIN PARACHUTE FAILURE

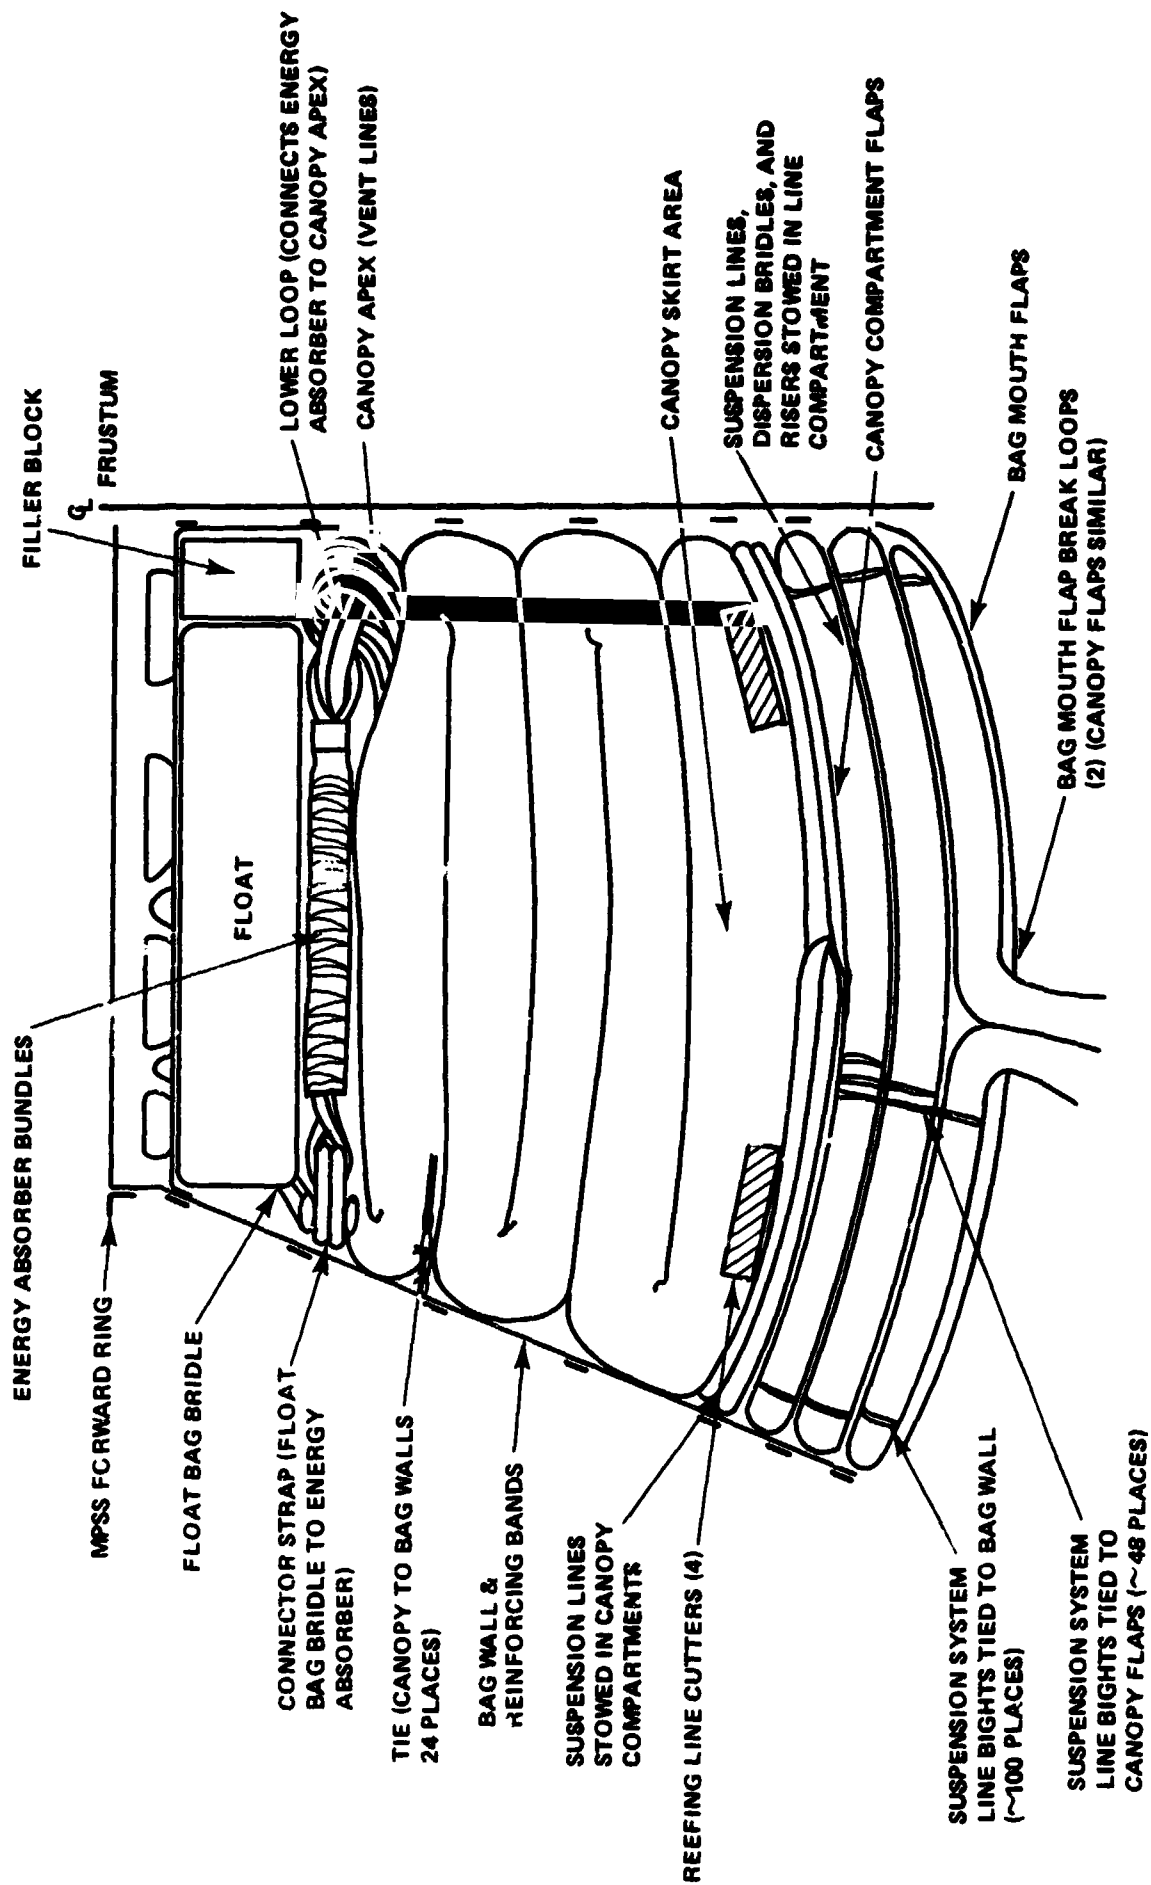
Figure 3. Packed main parachute - cross section.

In an effort to familiarize all team members with the packed geometry of the main parachutes and to gain a cursory understanding of the deployment process of the mains, a series of charts were prepared (Figs. 3, 4, and 5). Figure 3 shows a side view of the packed main parachute inside its bag, fastened into the isogrid structure. It shows the three separate areas inside the bag, the float area (at the top), the canopy area, and the suspension system area (dispersion bridles and risers). The figure also shows the canopy compartment flaps, the lower loop on the float system that attaches the energy absorber to the canopy apex, and the upper loop or connector strap that attaches the other end of the float energy absorber to the flat bridle.

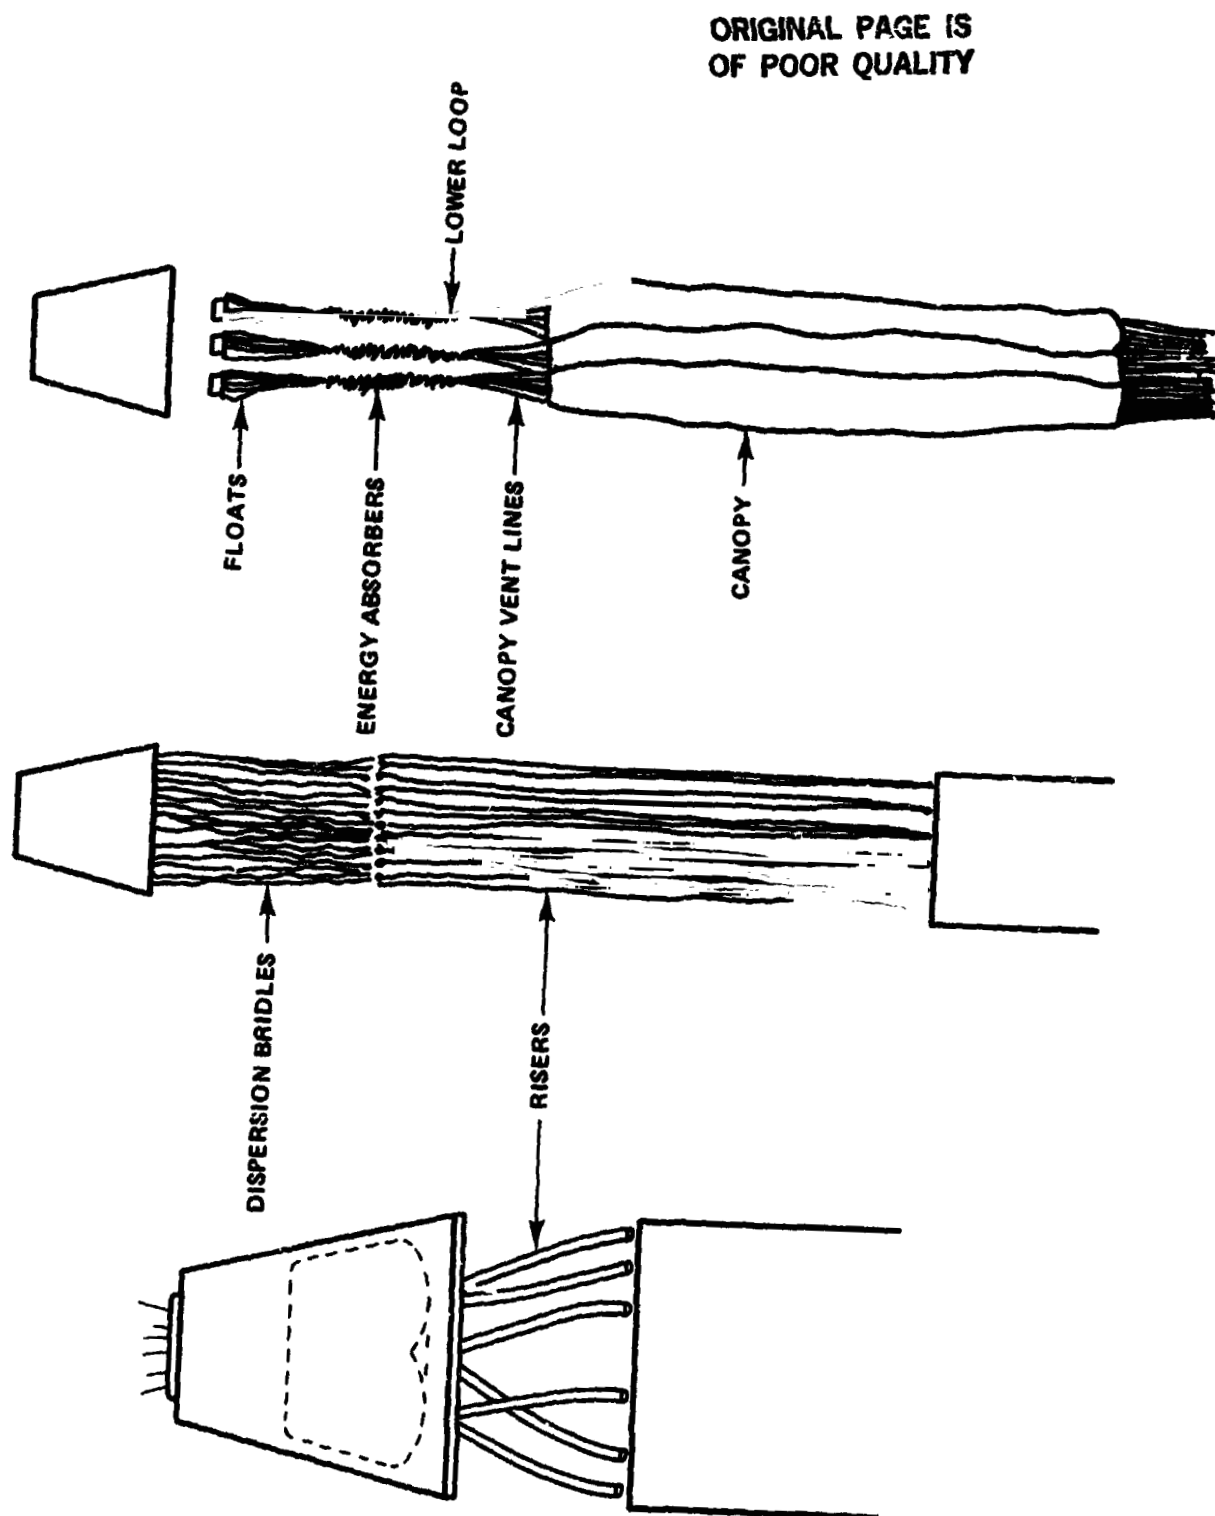
Figure 4. Idealized deployment sequence.

Figure 4 depicts an idealized deployment sequence of the main parachutes from the frustum as it is pulled away from the SRB by the drogue parachute. It shows a "lines first" deployment, e.g., the risers are the first elements out of the deployment bag, then the dispersion bridles, then the suspension lines, followed by the parachute canopy, and lastly the main parachute flotation system. It should be noted that when the floats are clear of the frustum, the frustum has separated approximately 250 ft from the SRB.

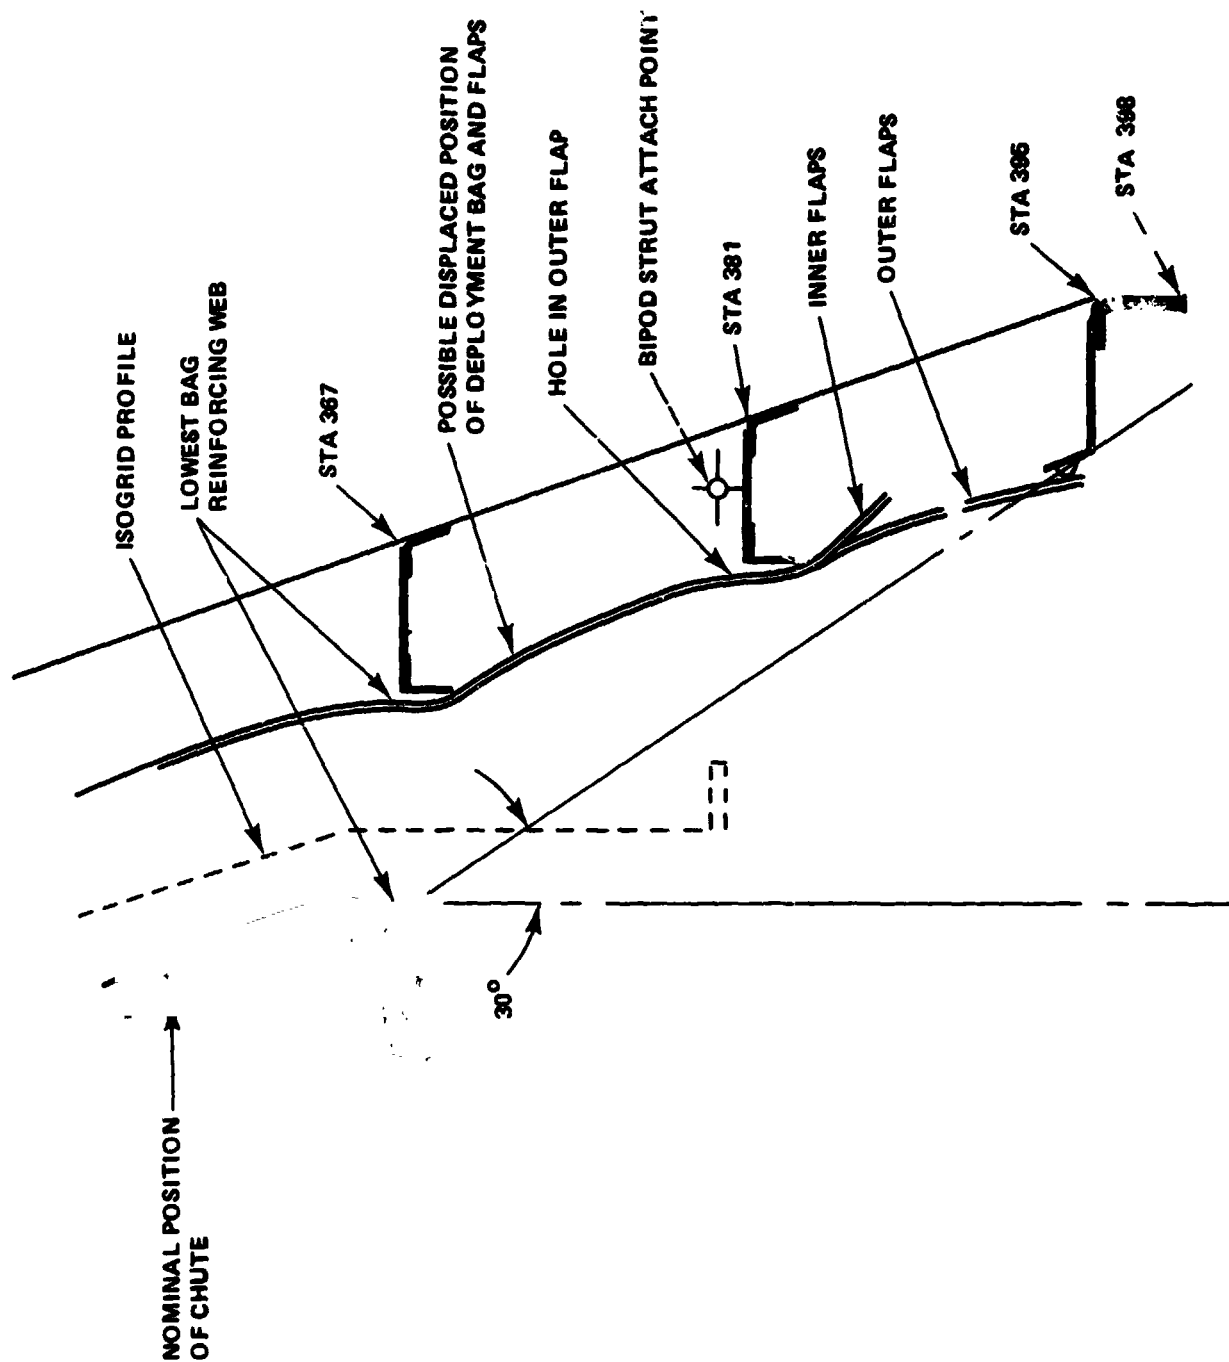
Deployment bag and frustum structure.

Figure 5 is a closeup view of the relative locations of the lower portion of the main parachute bag and the internal structure of the frustum. It shows that the bottom of the main parachute bag is 30 to 34 in. above the separation plane (Station 398) of the frustum. Ideally, the main parachute would deploy out of the bottom of the bag in a straight down fashion and not strike any of the frustum internal structure. However, Figure 5 shows that the parachute would only have to drift 30 deg sideways or conversely; the frustum would only have to tilt 30 deg to have contact with the parachute as it is deployed out of the bag. Parachute/frustum structure contact is very undesirable because the rapidly deploying nylon fabric (300 to 350 ft/sec) will melt due to frictional heat and its strength is then degraded.

Figure 5 shows the location of a hole found in the outer bag flap. This hole is believed to have been caused by the abrasion of the bag flap against the frustum structural ring at Station 381. This ring has a relatively sharp corner and, as such, is a hazard to nylon fabric.

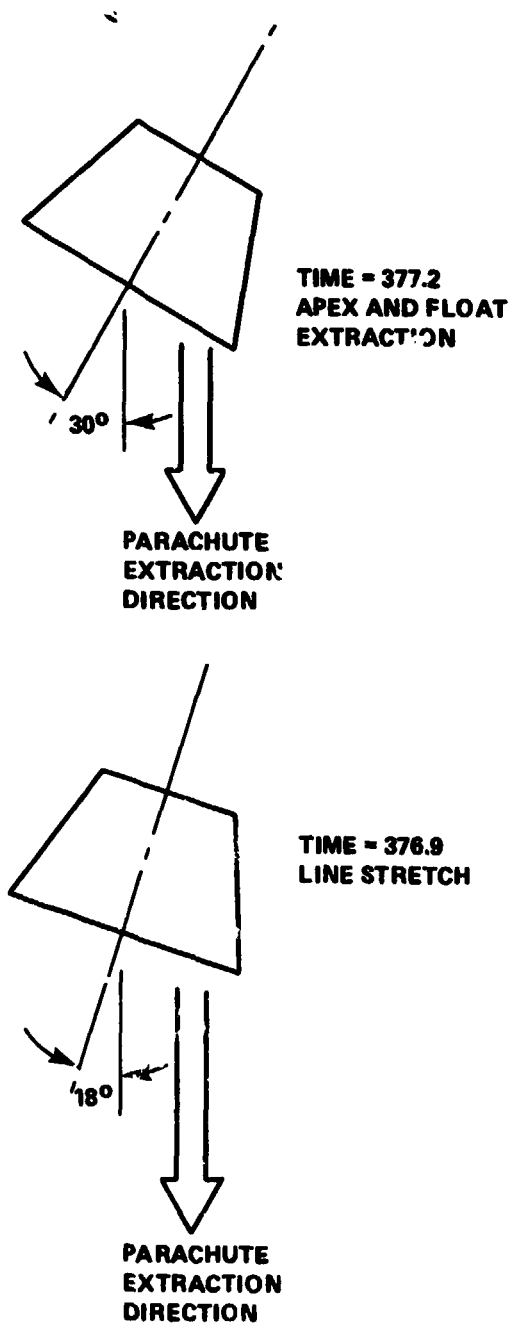
Figure 6. Frustum orientation during STS-3 parachute deployment.

After reviewing the 70mm 120-in. film from the tracking ship USS Vandenberg, a frustum skewing phenomena was observed during the main parachute deployment process. Dr. Dean Wolf of Sandia Laboratories determined that this frustum skewing could be caused by wake turbulence overtake. He had coauthored a paper presented to the 7th Aerodynamic Decelerator and Balloon Technology Conference October 21-23, 1981 [3]. That discussed the wake turbulence overtake phenomena. This violent action on the drogue parachute canopy forces it sideways, and the drogue suspension lines then pull the top of the frustum sideways, thereby causing a rotation of the frustum. Figure 6 shows the frustum rotational angle at main parachute line stretch and at main parachute apex and float extraction 0.3 sec later. The angles shown were measured from a couple of frames of the 70mm film. It can be seen that the measured 30 deg would be sufficient to prove frustum/main parachute contact. It is concluded that the large skew angle of the frustum at the time of main parachute float extraction was the initial cause of the parachute damage that was observed on canopy 2067. The floats probably struck or hung up on the frustum structure during the extraction process. Further analysis of the 70mm film showed that the floats were flailing around violently immediately after deployment and became entangled with the floats from an adjacent parachute (Serial No. 2065). This entanglement induced large asymmetrical loads into the vent lines. Vent line No. 51 finally failed. The sudden stored energy release caused the stretched vent line/radial (No. 3) to snap back. This recoiling vent line sheared the vent band at the radial No. 3 joint. There was sufficient energy left in the radial to continue shearing the top 30 to 40 horizontals between radials 3 and 4. Of the remaining 200 horizontals down to the skirt, all but the 13 bottom horizontals were failed by the strain action of the No. 3 radial. Figure 7 shows the relative positioning of the three main parachutes on A12 and the damage sustained by No. 2067 in the apex area of the canopy. Figure 8 shows a more detailed damage assessment of canopy 2067. It can be deduced from this view how the floats (entangled with adjacent canopy flotation) could have caused the observed damage pattern.

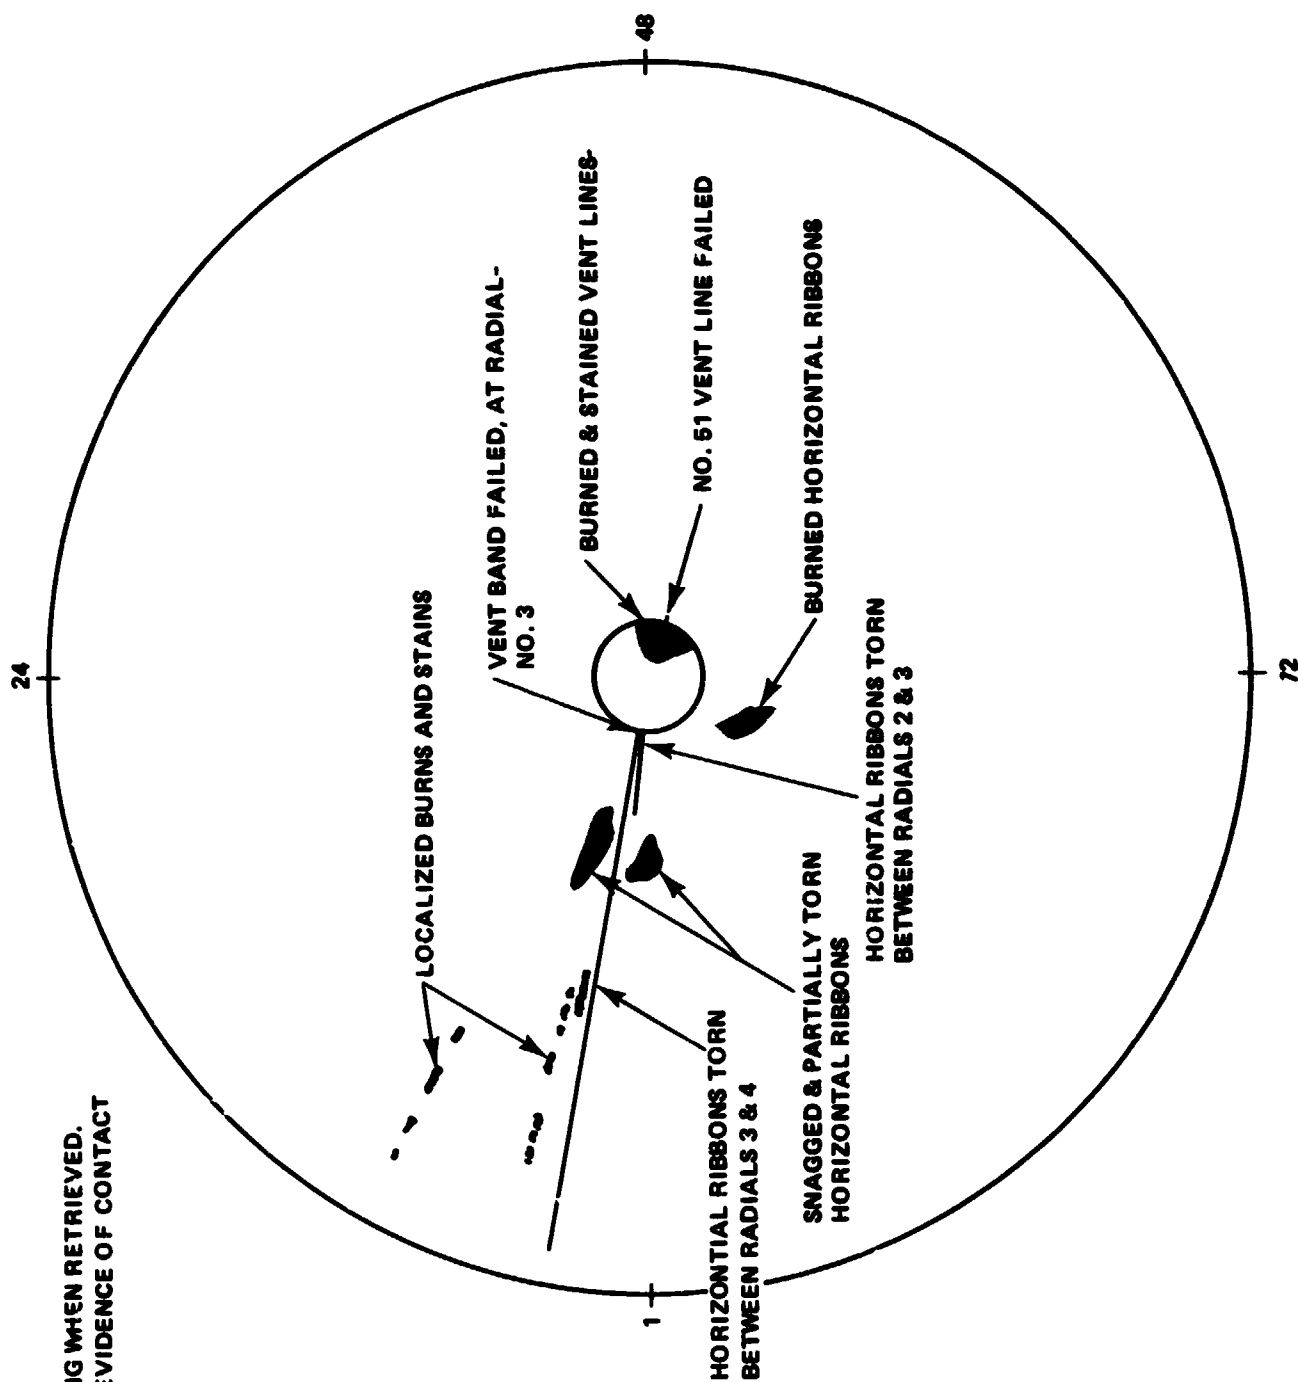
Figure 8. Significant damage areas, S/N 2067.

- FLOTATION MISSING WHEN RETRIEVED.
- MINIMUM VISUAL EVIDENCE OF CONTACT IN A12 FRUSTUM.

MAIN CHUTE S/N 2067 DAMAGE SUMMARY

FLOAT DAMAGE

- FLOAT SEPARATED FROM CANOPY BEFORE RETRIEVAL
- BOTH SIDE FLOATS SEPARATED FROM CENTER FLOAT
- FLOAT BAG BRIDLE LEGS PULLED AWAY FROM SIDE FLOATS (COMPLETE WITH ADD ON REINFORCING WEBS – TCTI B-52-5257-01)
- CENTER FLOAT BAG TORN WHERE SIDE FLOAT BRIDLE LEGS CROSS BOTTOM SURFACE
- PLA CAVITY FILLER AND CENTER FLOAT BRIDLE LEGS INTACT
- EXTENSIVE FRICTION BURN ON OUTBOARD END OF CENTER FLOAT
- ENERGY ABSORBER STROKE TYPICAL OF OTHER UNITS (STS-1, STS-2, AND STS-3)
- LOWER LOOP CONNECTING ENERGY ABSORBER TO CANOPY APEX NOT RECOVERED
- SEVERE BURNING INSIDE ENERGY ABSORBER LOWER END LOOP (ONE PLY). NO BURNING ON UPPER END LOOP

VENT AREA DAMAGE

- VENT BANDS SEVERED AT RADIAL NO. 3
- VENT LINE NO. 51 SEVERED, 3 in. FROM VENT BAND (CONTINUATION OF VENT LINE NO. 3)
- SEVERE ABRASION OF VENT LINES, GORES 42 THROUGH 59. ABRADED VENT LINES SHOW GREEN COLOR ON INSIDE OR OUTSIDE SURFACES
- BROKEN STITCHES IN VENT LINE JOINT GORES 48, 47, 43, AND 42

CANOPY DAMAGE

- VENT BAND FAILED IN VENT BAND/RADIAL INTERSECTION AT RADIAL NO. 3. TYPICAL TENSION FAILURE INDICATED. NO EVIDENCE OF CONTACT ON OUTSIDE OF VENT BAND
- 250 HORIZONTAL RIBBONS SEVERED IN GORE BETWEEN RADIALS 3 AND 4
- 34 HORIZONTAL RIBBONS SEVERED IN GORE BETWEEN RADIALS 2 AND 3
- HORIZONTAL RIBBONS SNAGGED AND PARTIALLY TORN, GORES 96 THROUGH 6, RIBBONS 30 THROUGH 60
- HORIZONTAL RIBBONS WITH BURNS, GORES 75 THROUGH 81, RIBBONS 8 THROUGH 20
- HORIZONTAL RIBBONS WITH BURNS AND O/D THREAD FRAGMENTS, GORES 4 AND 5, RIBBONS 86 THROUGH 99
- MISCELLANEOUS BURNS, SNAGS, PARTIALLY TORN RIBBONS DISTRIBUTED OVER REST OF CANOPY

DEPLOYMENT BAG

- TEFLON CLOTH LINER PULLED AWAY, OUTBOARD ARC OF BAG
- FRICTION BURN ON CANOPY FLAP NO. 4, INSIDE SURFACE, HOLE THROUGH FLAP
- CANOPY FLAP NO. 8 TORN FROM BOTTOM END 22 in. (OF 35 in.)
- LOCAL FRICTION BURNS ON CANOPY FLAPS 5, 6, 7, AND 8
- FRICTION BURN AND HOLE ON BAG MOUTH FLAP NO. 4, INSIDE SURFACE

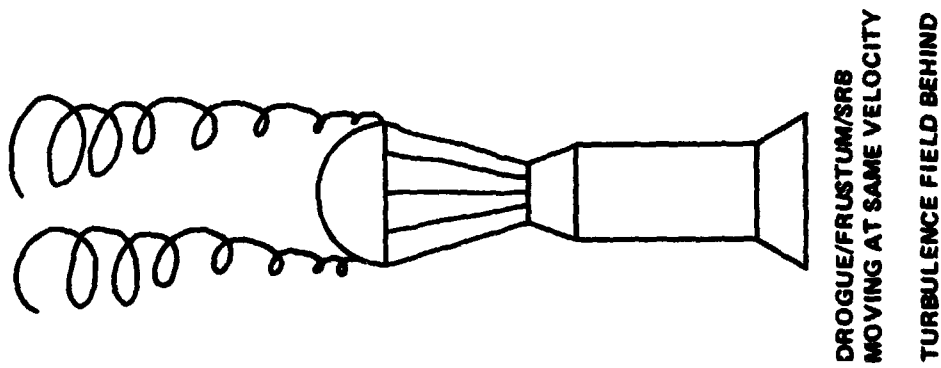
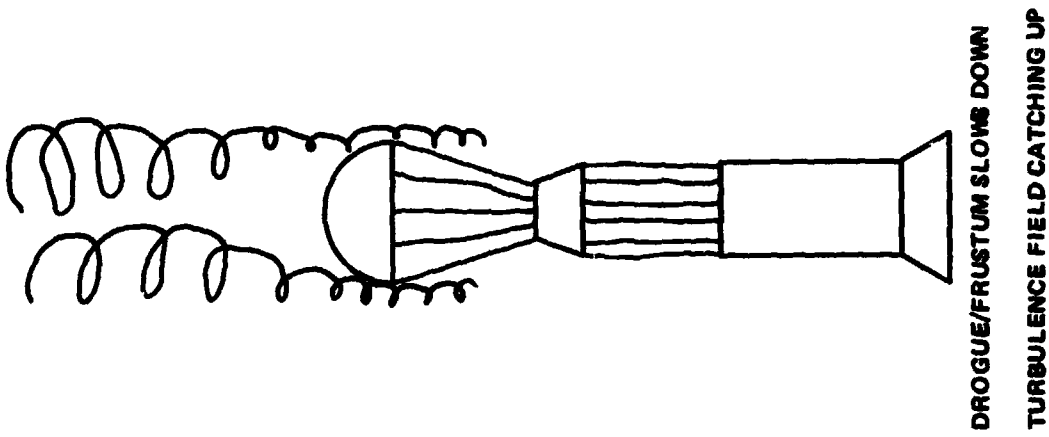
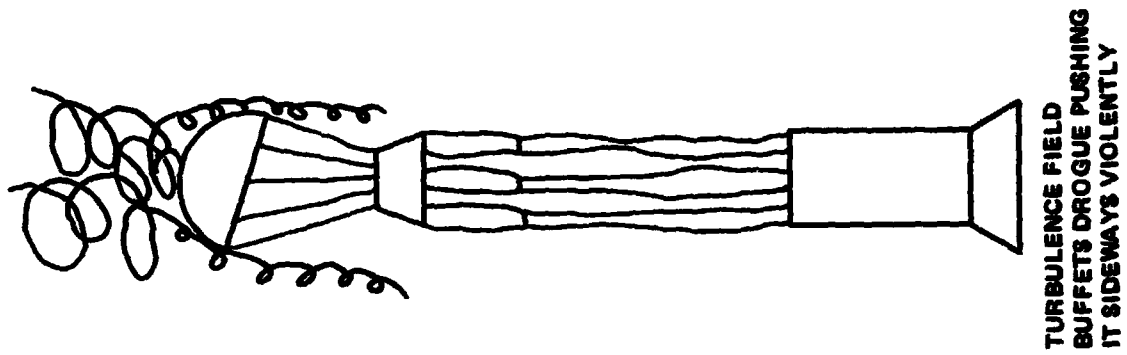
Figure 12. Wake turbulence overtake phenomena.

Going back and relooking at STS-1 film (we could not see all of mains deployment on STS-2 film because of cloud cover), revealed that STS-1 also experienced the wake overtake phenomena (Fig. 12). We compared aerodynamic data from STS-1, STS-2, and STS-3 to see if any trends could be determined that could be used to predict this phenomena. Table 5 shows a listing of the aerodynamic parameters at the time of Decelerator Subsystem deployment. No trends could be developed from this data since it appears to be random.

Since it is not possible to change the drogue parachute design to reduce the wake turbulence overtake effects, and it is concluded that this disturbance will randomly occur during the Space Shuttle program, corrective actions, or options, were established for the near term and long term. Table 6 shows these options and their rationale.
